Accu-Check Inspection

Confidential Inspection Report

133 Ingle

INSPECTION ADDRESS: 133 Ingle.
INSPECTION DATE: 12/23/2024.
INSPECTION NO: 241223-2.
CLIENT NAME: Pie 102 LLC.

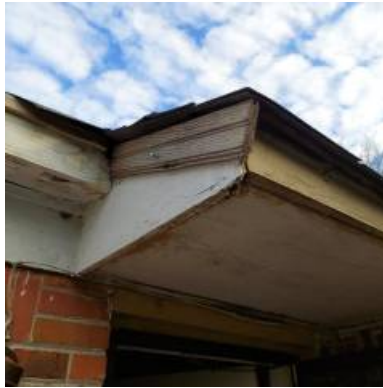
105 TRIM:

Wood. Recommend caulking/painting as needed. Bare wood noted at several areas.

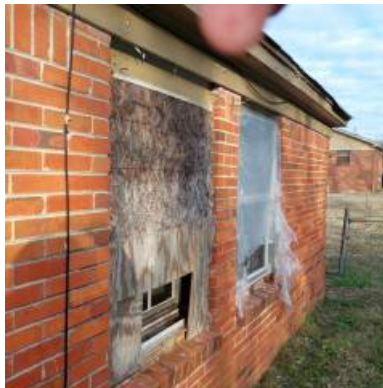
106 WINDOWS:

Type: Wood. Windows boarded up at exterior. Many appear to need replacement.

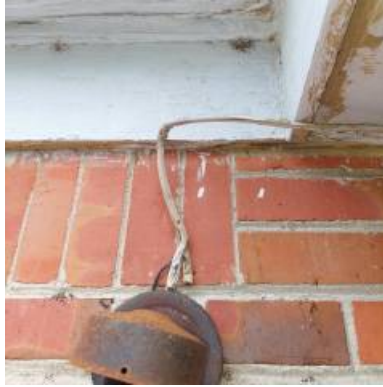
107 ELECT:

Exposed wiring noted at: Right side. Recommend review/repair as needed by licensed electrician.

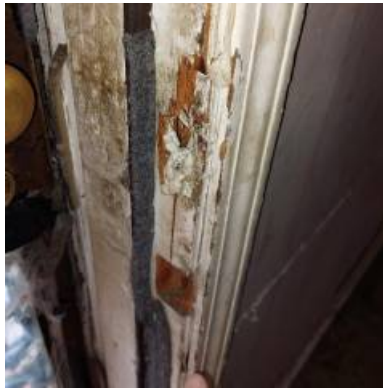
112 DOORS:

Strike plates missing at front door unit. Jamb damaged also noted. Recommend repair.

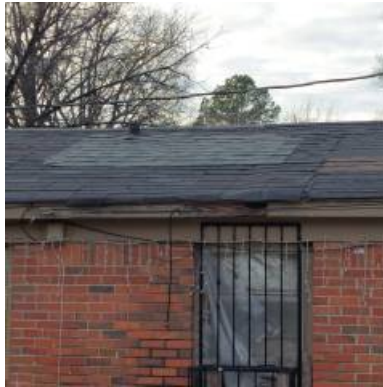
303 ROOF CONDITION:

It appears this roof has more than two layers of roofing present. Normally no more than 2 layers are acceptable. Missing shingles noted at: areas throughout. Active leakage noted. Recommend review/repair as needed by licensed roofing contractor.

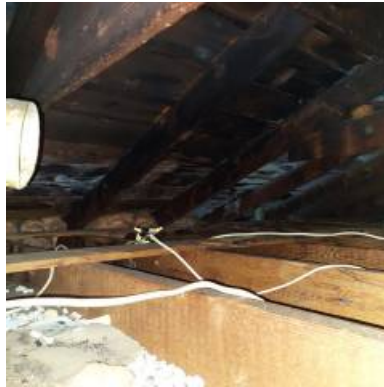
402 FRAMING:

Rafters. There was organic growth noted at the rafters and ceiling joists. Recommend repair as needed by a qualified mold contractor.

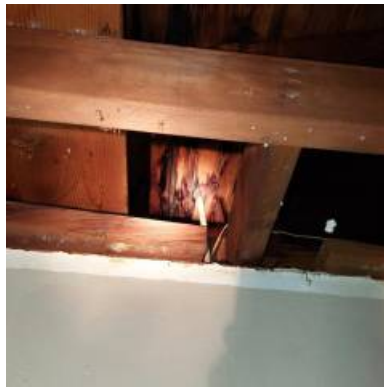
403 SHEATHING:

Wood plank. Damage from leakage noted. Mildew noted. Recommend repair as needed.

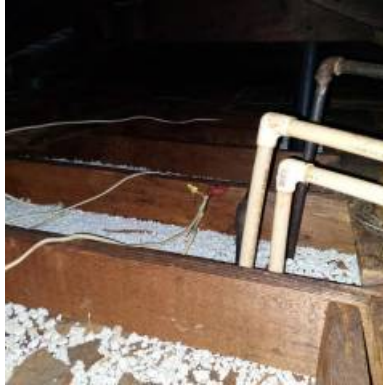
405 INSULATION:

Where visible approximate thickness is: 1-2 inches, recommend installing additional insulation. Recommend additional insulation in the attic area. Recommend to remove the styrofoam insulation materials.

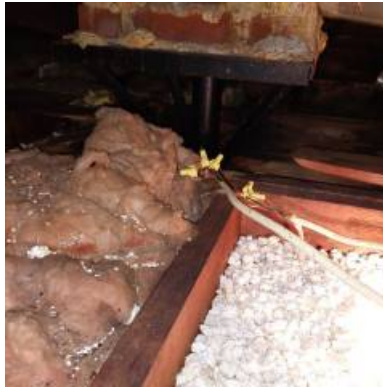
Open wiring splices noted; these should be encased in a junction box. Loose hanging wires noted. Recommend securing. Recommend review/repair as needed by licensed electrician.

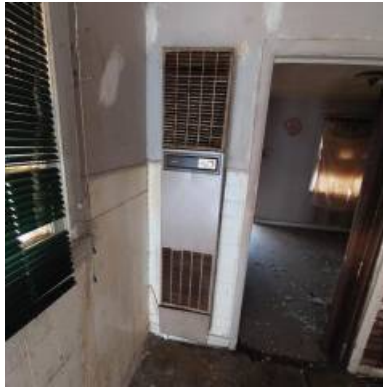
801 FURNACE LOC:

Gas wall heater present. Unit does not appear to be operable. Recommend replacement.

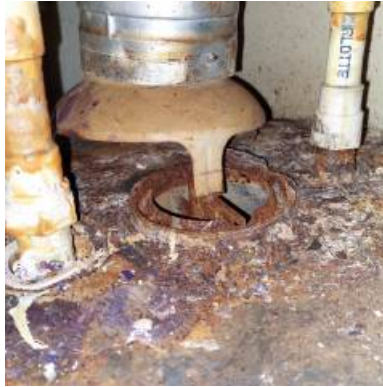
- 1011 BRAND: Located at: closet.
1012 FUEL/CAPACITY: Gas. 40 Gallons.
1013 WATER HTR COND: The unit is not installed in a level position. Significant rust noted at top of unit. Unit will need replacement.

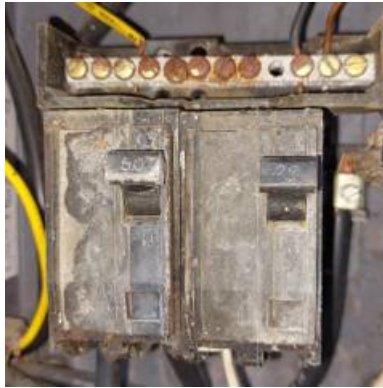
1104 ADDT COMMTS:

The interior panel could not be opened due to foam sealant sealing it shut. The electrical system appears to be only 50 amps. There is a requirement of at least 100 amps for a single family home. Recommend review/repair by licensed electrician.

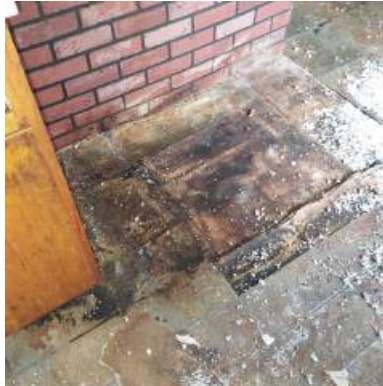
1301 FLOORS:

The flooring at this home was damaged throughout. Recommend replacement throughout as needed.

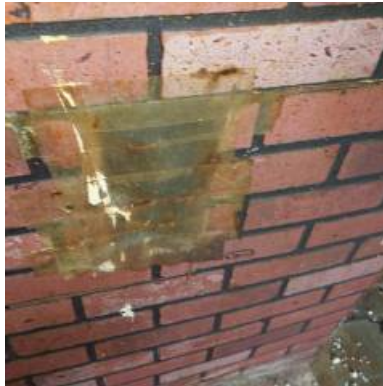
1302 WALLS:

There are holes noted at the kitchen area walls. Recommend review/repair as needed.

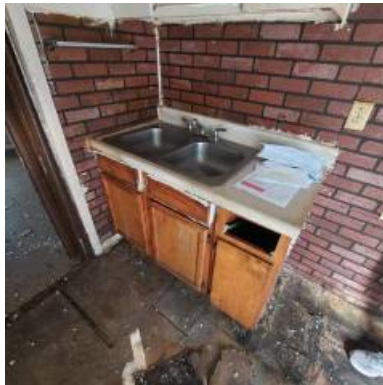
1306 CABINETS:

Missing drawer noted. Recommend review/repair as needed.

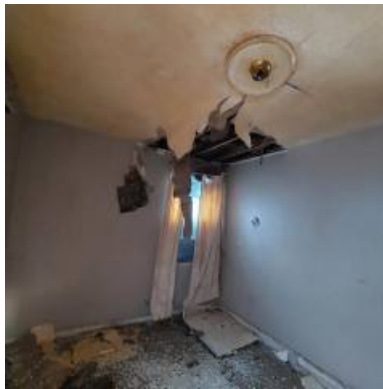
1501 LOCATION: Located at: front.
 1502 FLOORS: Damage/deterioration is noted.
 1503 WALLS: Moisture stains noted. Staining noted. Recommend review/repair as needed.
 1504 CEILINGS: Deterioration noted. Sagging noted. Visible mold noted. Recommend review/repair as needed.

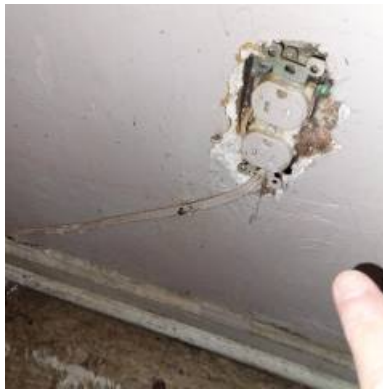
1505 DOORS: Serviceable.
 1506 WINDOWS: Serviceable.
 1507 ELECTRICAL: Some lights are inoperable. Improper use of extension cord noted at outlet. Recommend review/repair as needed by licensed electrician.

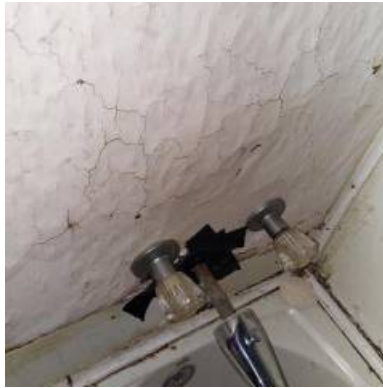
2201.1 BATH LOCAT:	Hall.
2202.1 FLOORS:	Damage noted.
2203.1 WALLS:	Deterioration noted. Recommend review/repair as needed.
2204.1 CEILINGS:	Staining noted.
2205.1 DOORS:	Damage noted. Recommend repair.
2206.1 ELECTRICAL:	Serviceable.
2207.1 WINDOWS:	Present.
2209.1 HEAT SOURCE:	N/A, Recommend repair.
2210.1 TUB/SURROUND:	Wall damaged. Recommend repair.

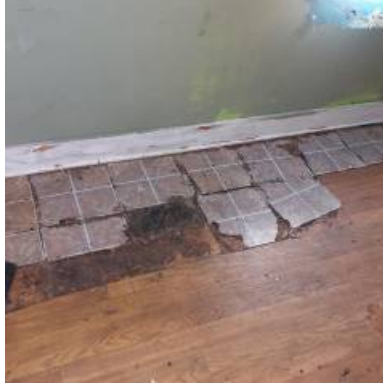
2302.1 FLOORS:

Deterioration noted. Recommend review/repair as needed.

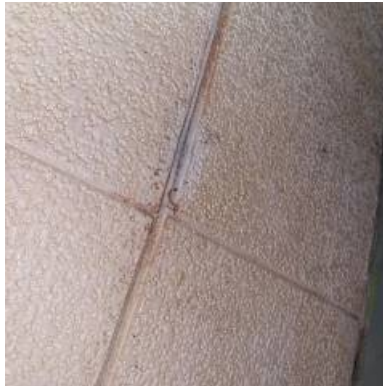
2304.1 CEILINGS:

Stains noted. Damage noted. Styrofoam ceiling tiles noted. Fire hazard. Recommend review/repair as needed.

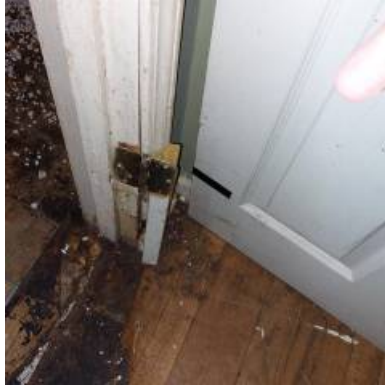
2305.2 DOORS:

Door missing. Recommend review/repair as needed.
